Aviation Safety

Letter

Issue 1/97

V_1 Decision

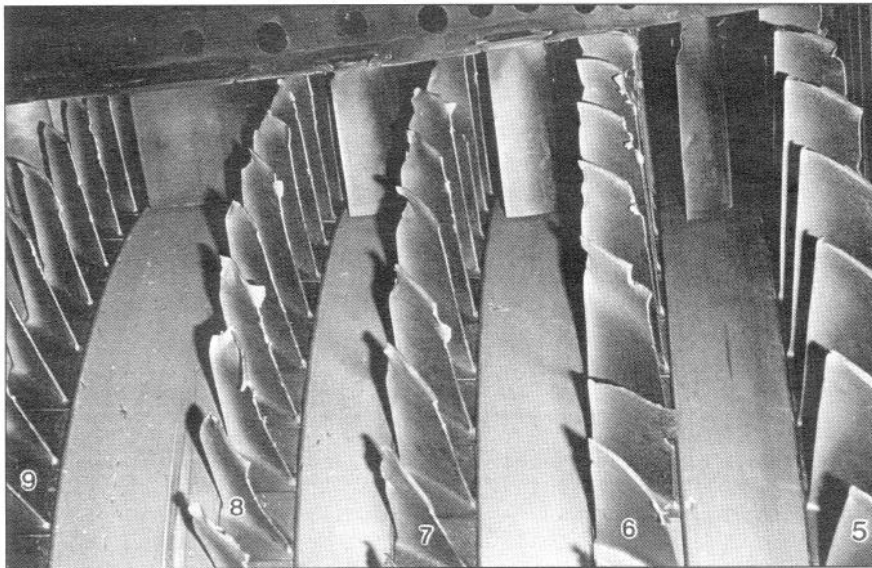
Detailed investigation showed that the No. 1 engine had suffered a series of blade failures resulting in compressor stalls. The explosive bangs heard were not recognized by the crew as compressor stalls.

On the morning of the occurrence, analysis of data taken earlier showed a small upward drift of nine degrees in the EGT. However, since a similar small variation had been noted a month earlier amid readings in the normal range, it was considered as a normal variation or scatter. Had the data for the two preceding days been available, it would have shown the trend continuing upward to 27 degrees, accompanied by increases in fuel flow and engine core speed (N2). A shift of that magnitude would have resulted in an immediate bore-scope inspection of the engine and detection of the progressive blade failures in the high-pressure compressor.

Compressor stage 5-9.

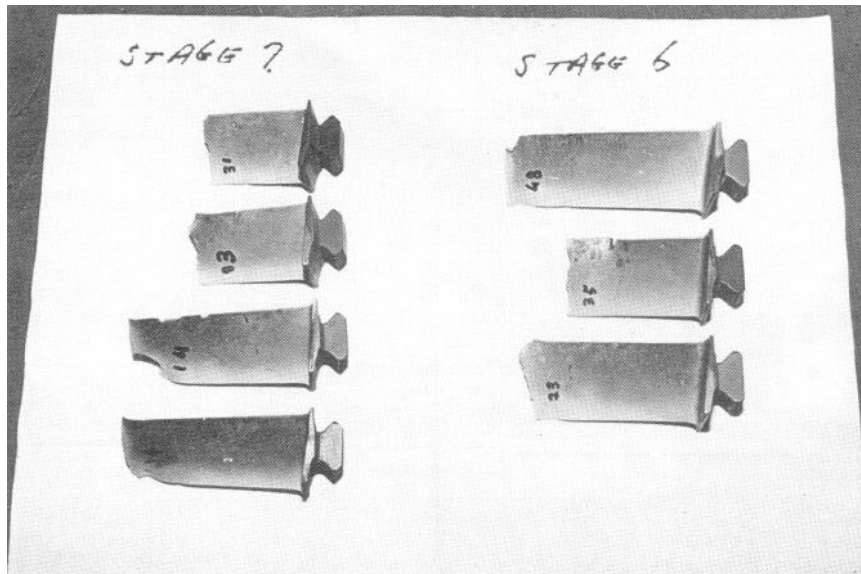
Compressor blades.
