## Aviation Safety

# Letter

TP 185E  
ISSN 0709-8103

**Issue 4/96**

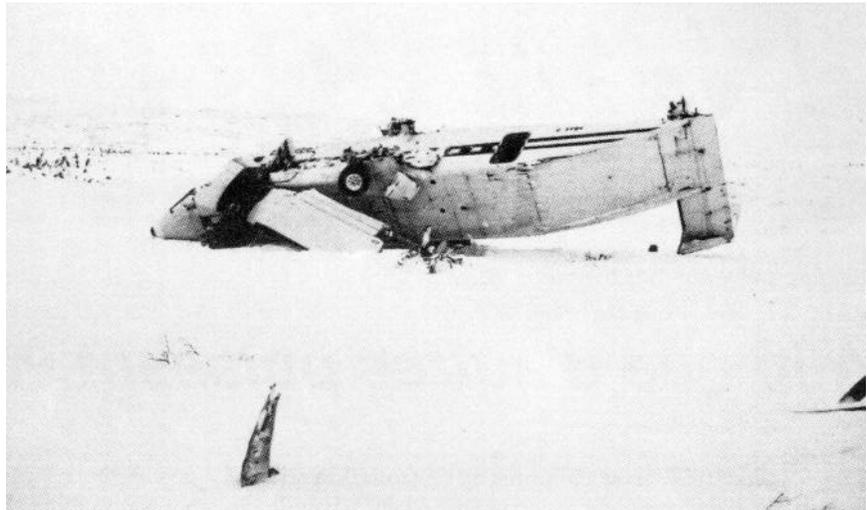
But they all survived.

*During their 26-minute flight, the crew received four separate weather reports: "obscured ceiling 100 feet, light freezing drizzle and probable severe turbulence on approach," and yet, they decided to continue.*

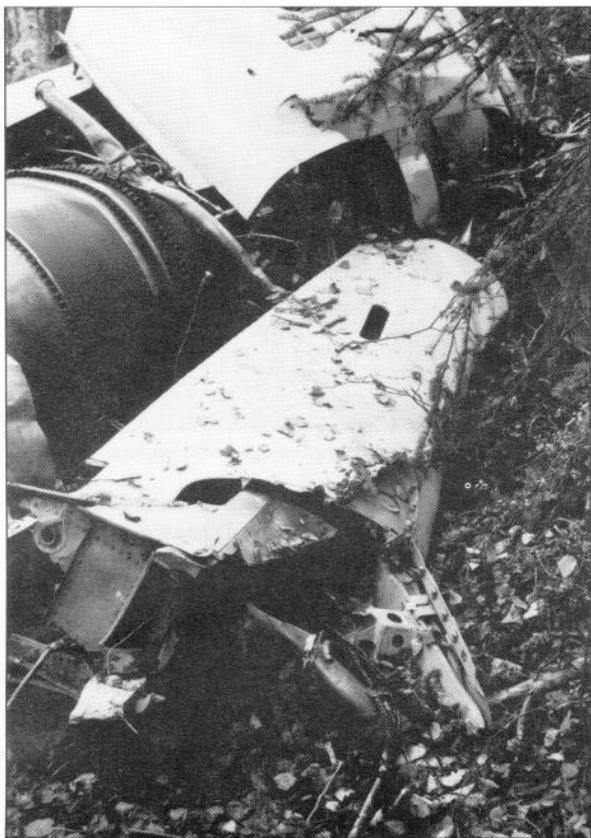
AWACS wreckage.

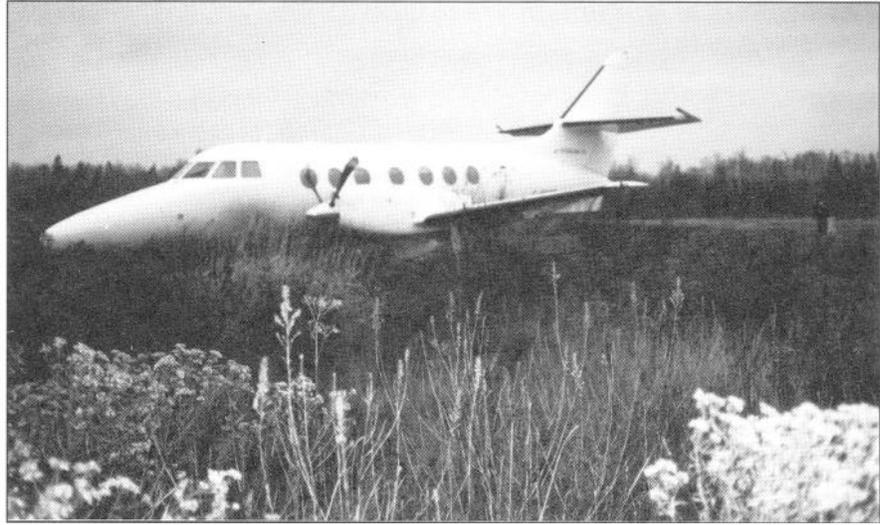
Takeoff aborted by bird strike.
