Aviation Safety

Letter

Issue 1/97

V_1 Decision

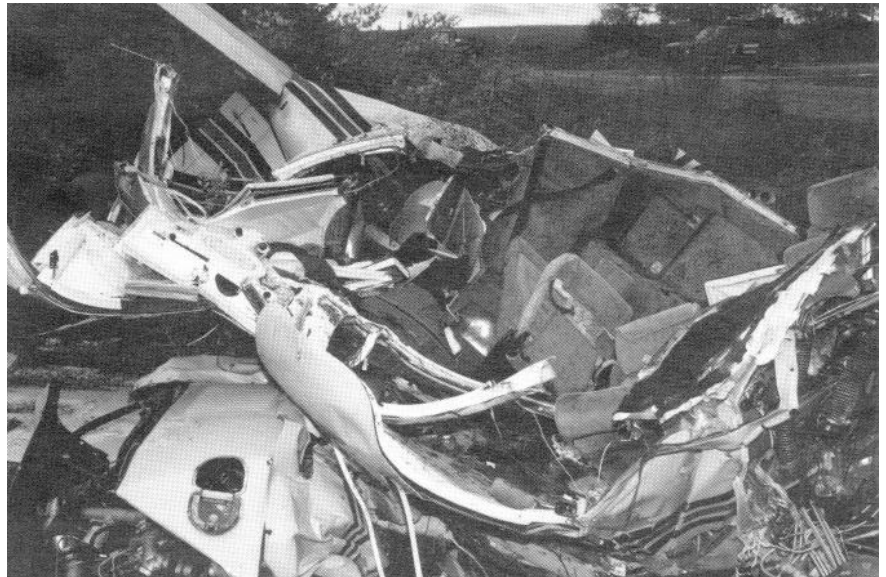
The TSB accident report (A95W0153) records the aircraft as being 400 pounds (eight percent) overweight; the landing gear was down at impact; and the nose baggage door was open.

The Seneca III forward baggage door is located on the left side of the nose, is hinged at

the top and opens upward. The door is secured in the CLOSED position by rotating the spring-loaded latch handle 90 degrees clockwise to the horizontal position. This extends two pins into the doorframe. The key lock is then rotated 90 degrees clockwise to the LOCKED position, and the key is removed from the lock. If the key can be removed at other than the fully locked position, lock and key must be replaced.

A one-time Airworthiness Directives and Piper Service Bulletin requiring inspection of the forward baggage door had been complied with seven years earlier. In addition, one month before the accident, the 100-hours inspection of the door hinges, latches and locks had also been signed off as completed. Yet the investigators' examination found the key and lock tumblers were so worn that the key could be removed in any position. The aircraft was not equipped with a "Door Open" warning light.
